Assessing Methodologies for Detecting Water Intrusion in Wall Systems: Phase 2

CRADA Final Report
CRADA Number NFE-20-08325

ORNL/LTR-2023/2941

**ASSESSING METHODOLOGIES FOR DETECTING WATER INTRUSION IN WALL
SYSTEMS: PHASE 2**

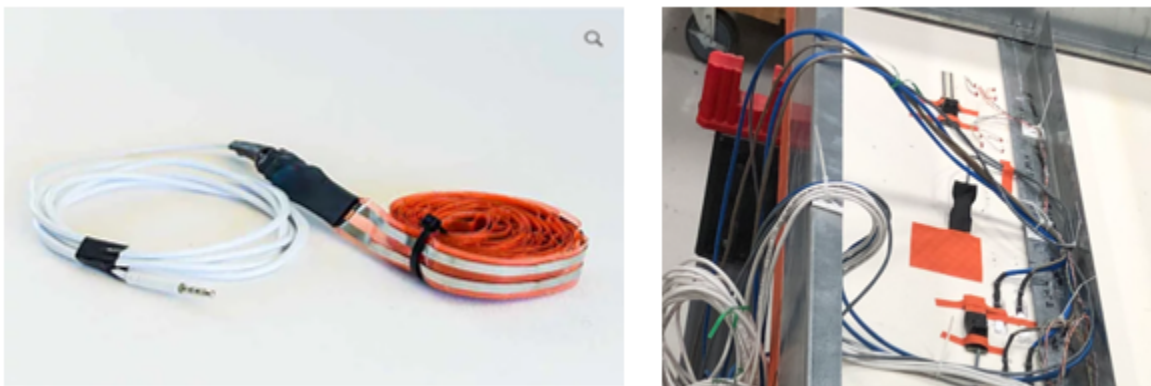
Figure 5: SMT electric sensor tape was placed horizontally on both surfaces of the exterior gypsum sheathing.

- Structure Monitoring Technology (SMT) electric sensor tape placed on the backside of the sheathing and between the water resistive barrier and the exterior gypsum sheathing. See Figure 1.
- Embedded moisture pin probes in the sheathing, inserted from the interior side of the gypsum sheathing to meter the moisture content at mid-thickness and the exterior side of the gypsum sheathing. See Figure 2.
- Capacitance-type RH sensors placed on the backside of the sheathing and between the water resistive barrier and the exterior gypsum sheathing. See Figure 2.

Electric sensor tape manufactured by Structure Monitoring Technology (see Figure 1) was used to measure the potential for a moisture leak. A short 6-inch length of the tape was installed on the backside of the sheathing and between the water resistive barrier and the exterior gypsum sheathing. The electric resistance output of the tape was monitored during the duration of the ASTM E331 spray exposure. When the tape is exposed to moisture, the electrical resistance of the tape decreases appreciably. The tape acts as “yes/no” sensor indicating the presence of water on the sensor.

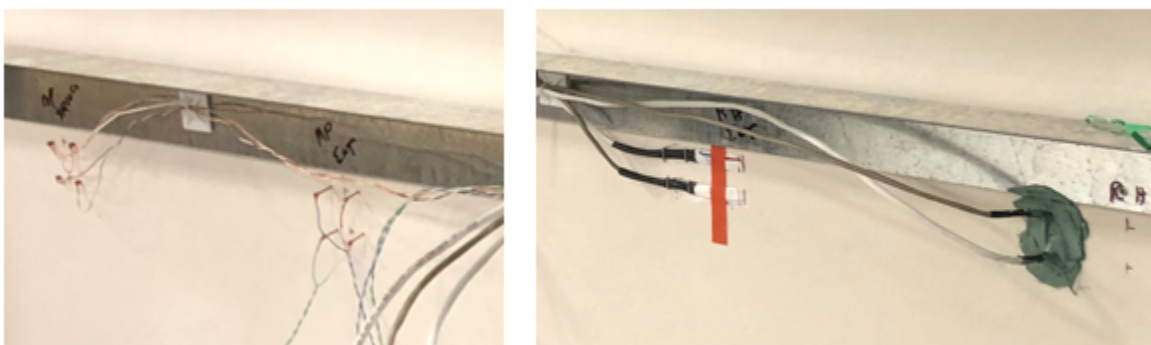
Figure 6: Moisture pin probes (left) and capacitance-type RH sensors (right) are embedded in the exterior gypsum sheathing.

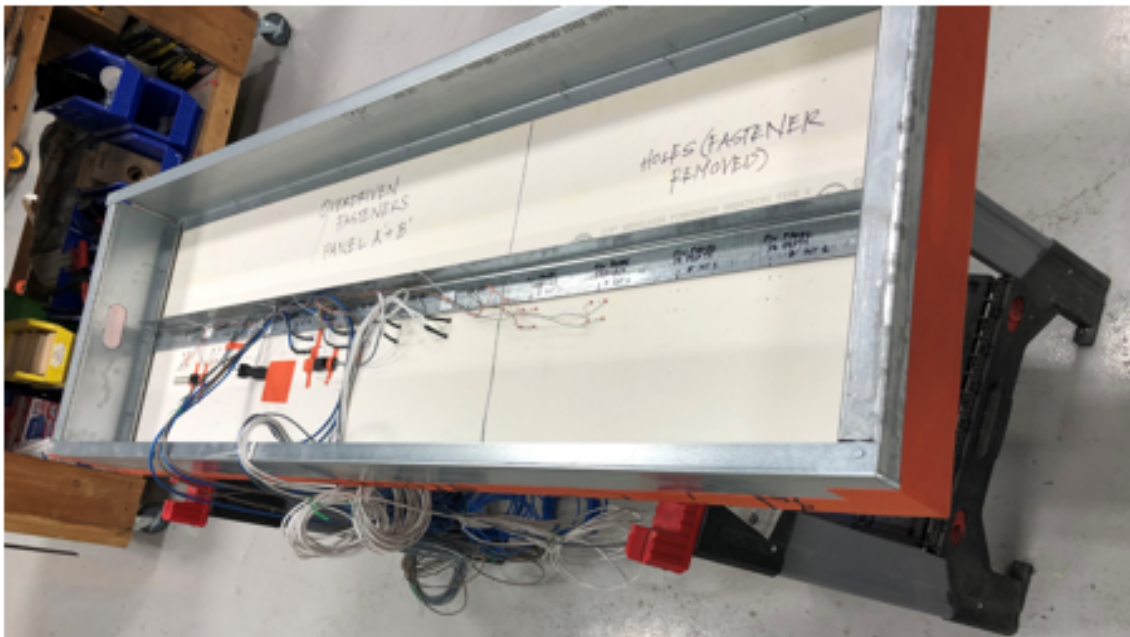
Figure 7: Test panel A/B during the application of the sensors.

To accelerate the testing process, it was decided to combine several of the panels. Panels A and B, Panels C and D, Panels A' and B', and Panels C' and D' were combined. The overall panel size was increased to 72 inches long by 24 inches high. These panels were installed in a wood buck having an appropriately sized aperture with a factory-bonded membrane and sealed in place. An image of the sensors installed in one of the panels is shown in Figure 3. Figure 4 shows the wood buck with panel aperture and installed panel.

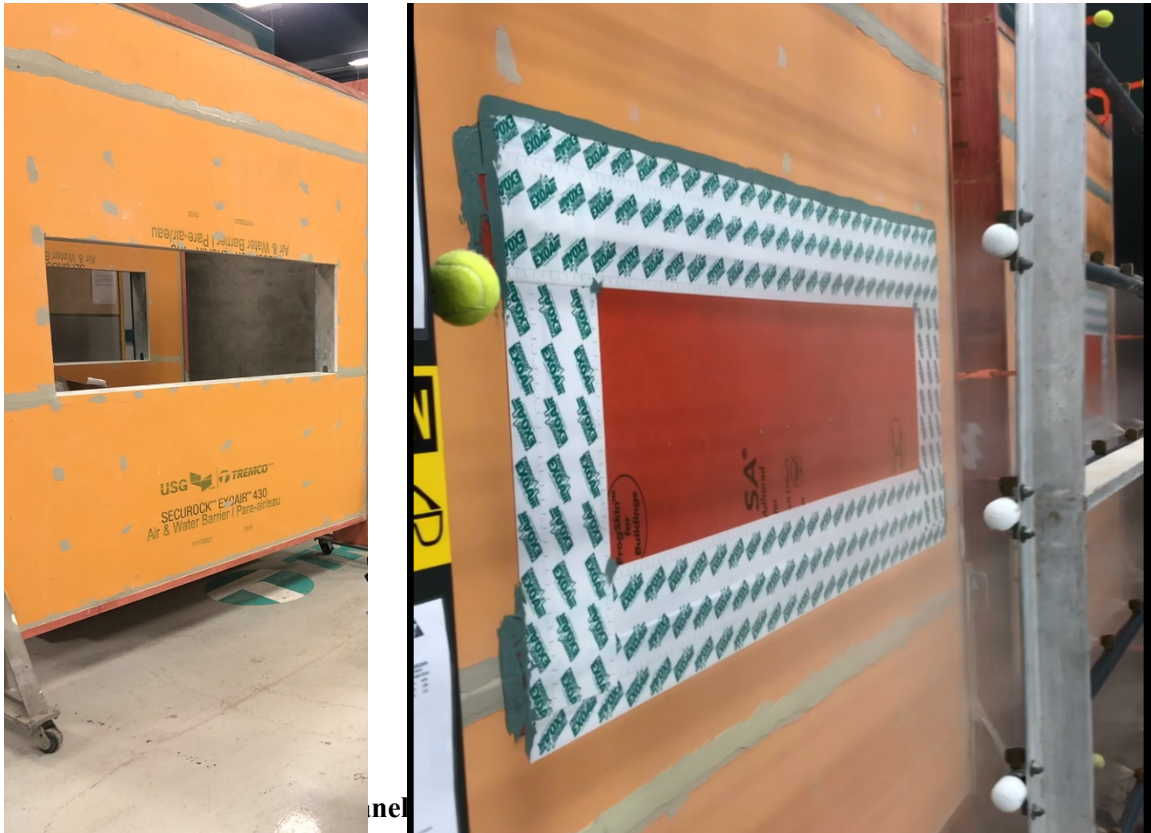
Figure 8: Wood buck with panel aperture (left) and panel installed (right).

Two panels were evaluated concurrently. Test bucks made of wood was constructed to hold a single test panel. The test buck was coated with a waterproofing material and the test panels were sealed into the buck using flashing tape and waterproofing sealant. The panels were tested with a 6.24 psf pressure difference across the specimen.

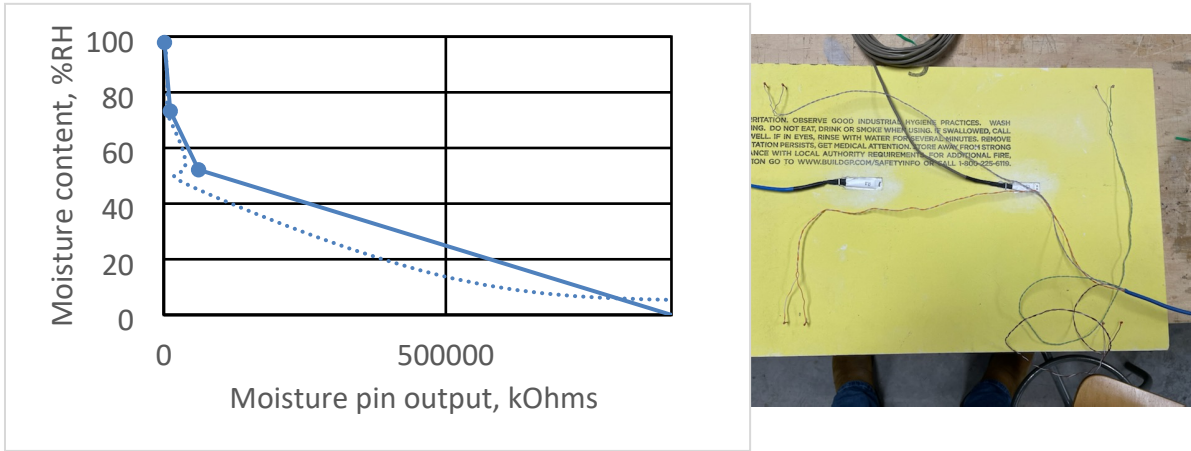
Figure 5: Moisture pin calibration data used for processing moisture pin data and photo of test sample used to collect these data.

Representative moisture pins and capacitance sensors were evaluated to assess the relationship between their output and moisture content. A sample of the exterior sheathing that was being used in the ASTM E331 experiments was instrumented with several moisture pins and capacitance sensors in a similar manner (see Figure 5). Prior to its use, the sheathing board was conditioned to constant weight in a drying chamber maintained at 100°F and less than 5 percent relative humidity. The instrumented board was placed in an environmental chamber that was controlled at 75°F and varying levels of relative humidity. A NIST-traceable Vaisala HMP7 temperature and relative humidity probe was used to monitor the hygrothermal conditions within the environmental chamber. The environmental chamber was maintained at 5, 50, 75, and 95 percent RH for over a week at each condition. After maintaining each condition for over a week, the outputs of the moisture pins and capacitance sensors were recorded. The moisture pin outputs were plotted against the Vaisala HMP7 temperature and relative humidity probe output, was fitted to a logarithmic function, and is also presented in Figure 5. This calibration was then used to process all of the data gathered during the ASTM E331 testing. The outputs of the capacitance sensors were compared with the calibration data supplied by the sensor manufacturer; data collected on the capacitance sensors tested in the environmental chamber agreed well with the manufactured-supplied calibrations. For the ASTM E331 tests, the supplied calibrations were used to process the capacitance sensor outputs.

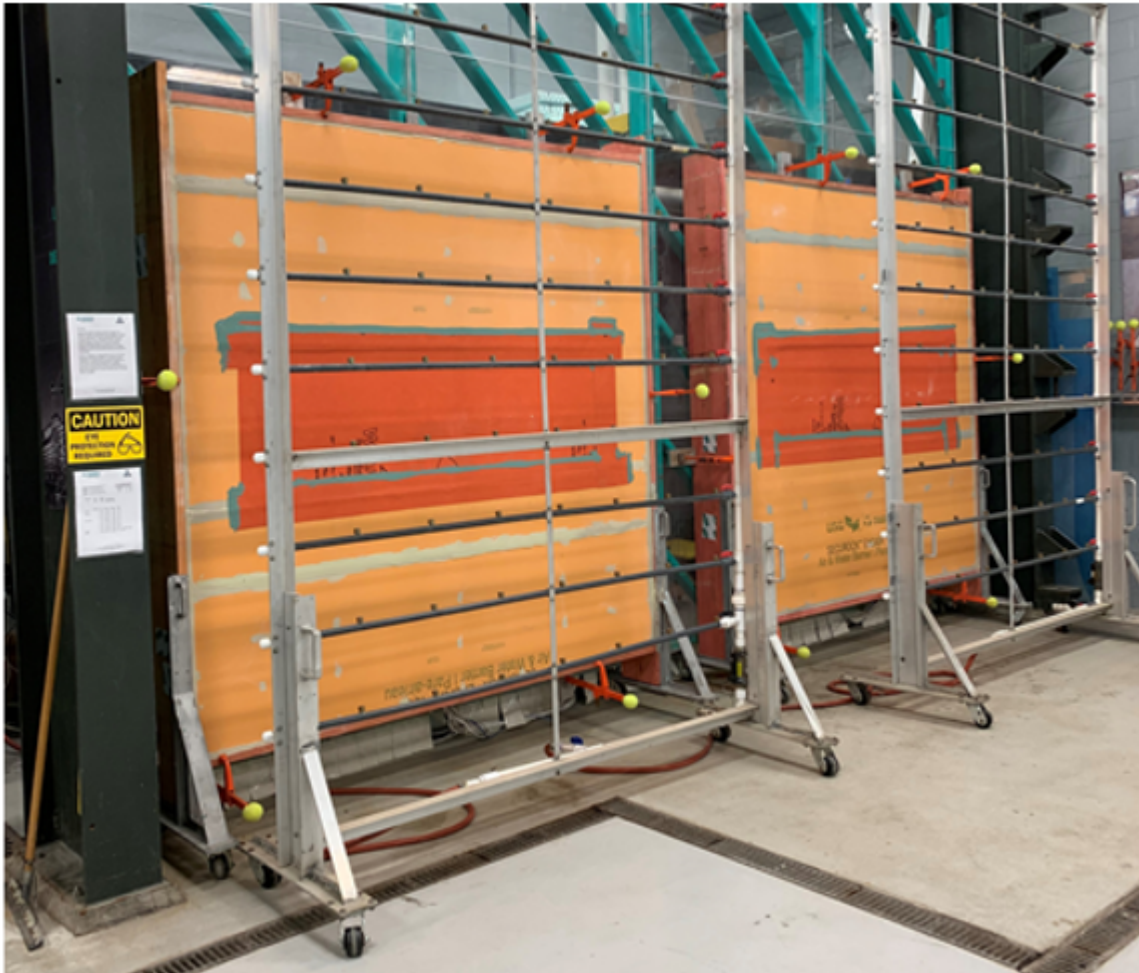
Figure 6: Test panels installed in an ASTM E331 apparatus.

Each panel was subjected to water sprayed on the surface of the panel in accordance with ASTM E331, Standard Test Method for Water Penetration of Exterior Windows, Curtain Walls, and Doors by Uniform Static Air Pressure Difference using the facilities at Tremco in Beachwood OH. The Tremco Sustainable Building Solutions Test Facility is a state-of-the-art facility for testing of air and moisture infiltration/exfiltration in building enclosures test specimens. Panels A/B and C/D were exposed for 120 minutes while Panels A'/B' and C'/D' were subjected to a 240-minute exposure. See Figure 6.

The water-spray system was configured to deliver water uniformly against the exterior surface of the test specimen at a rate of 5.0 U.S. gal/ft²·h. The water-spray system had nozzles spaced on a uniform grid, located at a uniform distance from the test specimen, and were adjusted to provide the specified quantity of water in such a manner as to wet all the test specimen and areas vulnerable to water penetration uniformly.

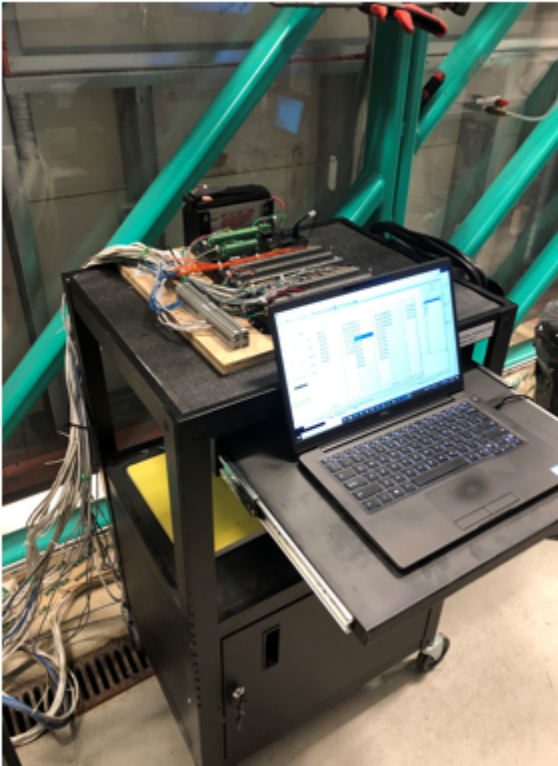
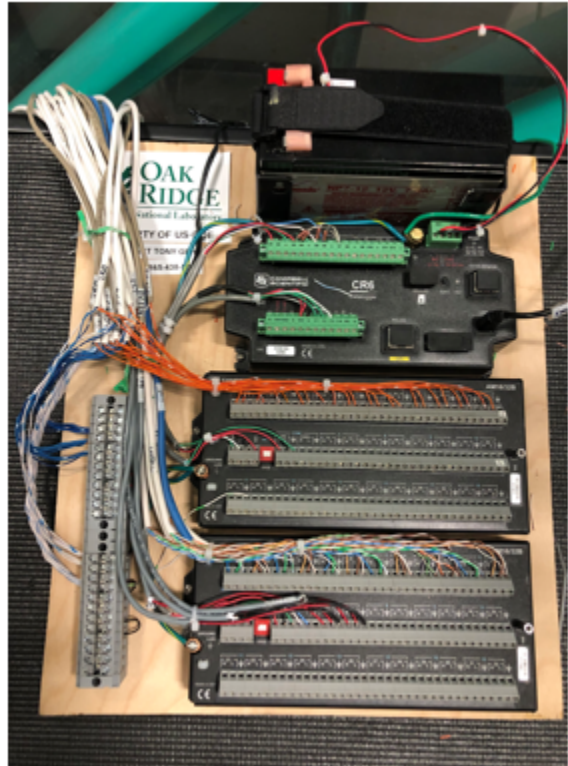
Figure 7: Data collection systems were used to collect and store data outputs from sensors installed in the test panels. Computers were connected to the data loggers (left photo) for this purpose. Campbell Scientific data loggers were used to collect real time data (right photo).

Each specimen was observed and photographed during the testing. The moisture pins, electric resistance tape, and the capacitance pins required a data collection system to compile data during the experiments. To accomplish this a Campbell Scientific data acquisition system was set up and used to collect this information. See Figure 7. After the spray exposure was completed, the data collection was continued overnight to examine the drying rate of the panels.

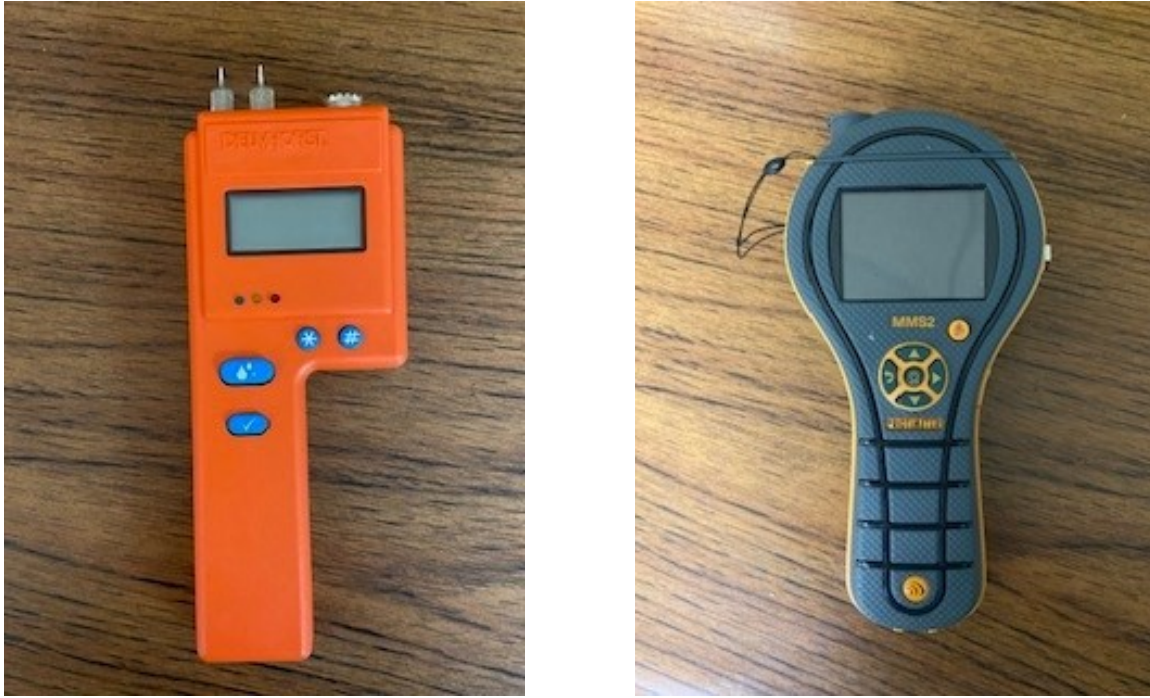
Figure 8: Delmhorst BD-2100 and Protimeter MMS2 moisture meters used in this study.

After the test panels completed their exposures, the panels were removed from the apparatus and two handheld moisture meters were used to measure the moisture content of the exterior gypsum from the interior side of the test wall. The first moisture meter that we employed were the Delmhorst BD-2100 and was set on the “gypsum” scale which, according to the manufacturer, measures the moisture content over the range of 0.2 to 50 percent. The second moisture meter used was the Protimeter MMS2. Photos of these meters are displayed in Figure 8.

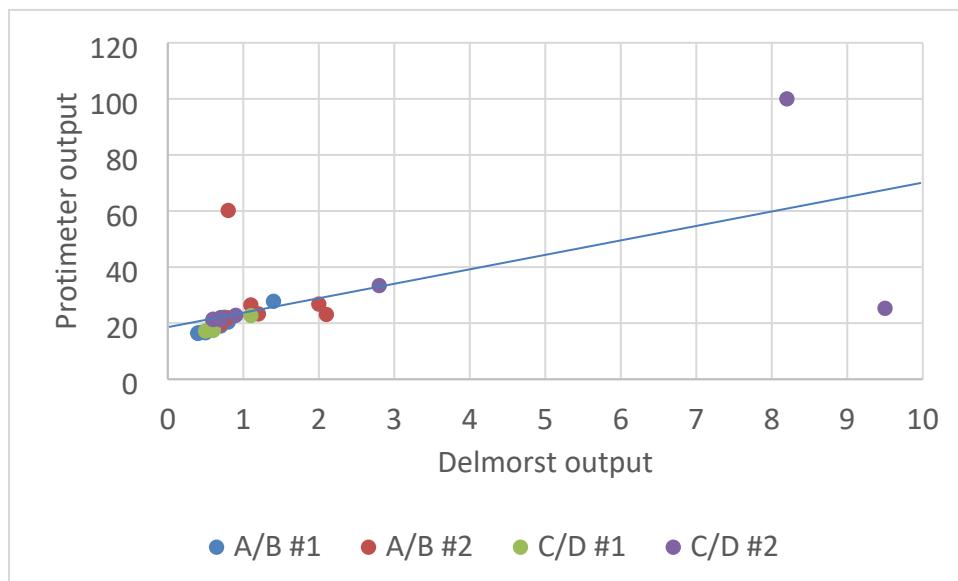
Figure 9: The comparative outputs of the two handheld moisture meters.

Data compiled with the moisture meters are summarized in Tables 6 and 7 and Figure 9. By plotting the outputs of the two moisture meters against each other, we can assess how their outputs compare. A linear fit was calculated for the 42-point data set and is depicted on Figure 9. Of the forty-two sets of data collected, only three of those data points significantly deviate from the linear fit. Approximately 90 percent of the data collected shows reasonable agreement between the two moisture meters. The three sets of data that are inconsistent with the curve fit were all collected by the second operator.

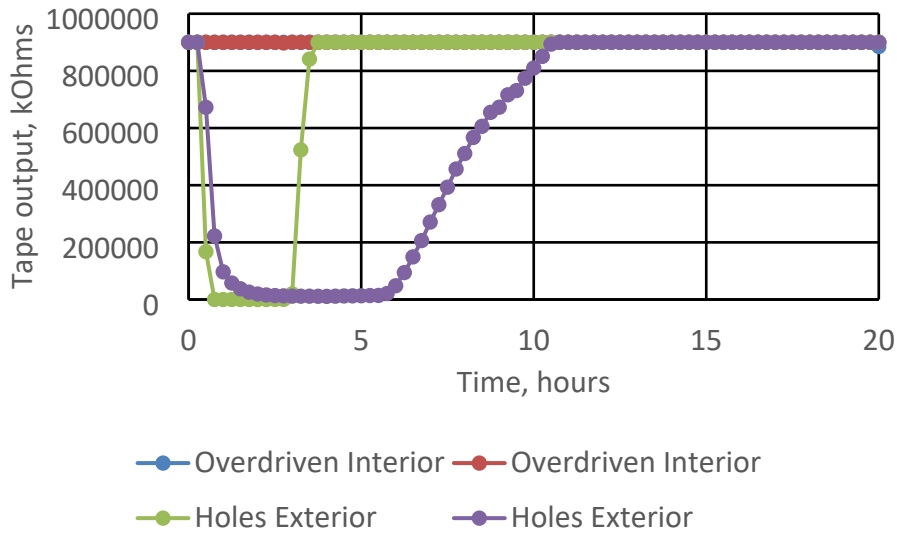
Figure 10: Tape outputs from 2-hour spray exposure experiment.

Figures 10 and 11 summarize the electric sensor tape for exposure tests from 8 March 2022 (two-hour spray exposure) and 9 March 2022 (four-hour spray exposure), respectively.

Data from both experiments show that the tapes used in association with holes in the water resistive barrier and exterior sheathing allow sufficient water to penetrate the into the panel and short circuit the sensor tape causing the electrical resistance to be substantially reduced. The tapes monitoring the overdriven fastener sites do not respond during the spray period indicating that insufficient amounts of water penetrate to these tape sensors. Similar data was collected during the 4-hour spray exposure with sensors monitoring sites associated with holes responding to an electrical short created by the leaking water and the tapes monitoring the overdriven fastener sites not responding.

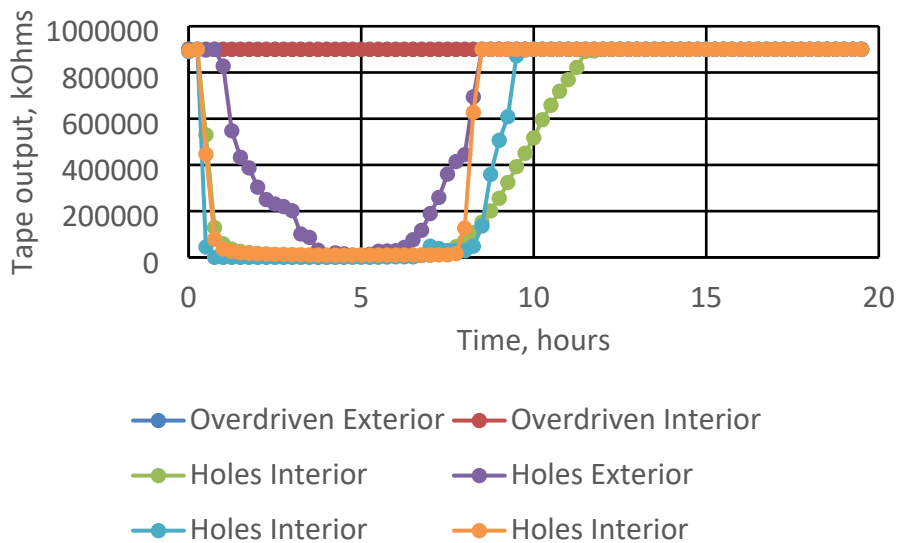
Figure 11: Tape outputs from 4-hour spray exposure experiment.

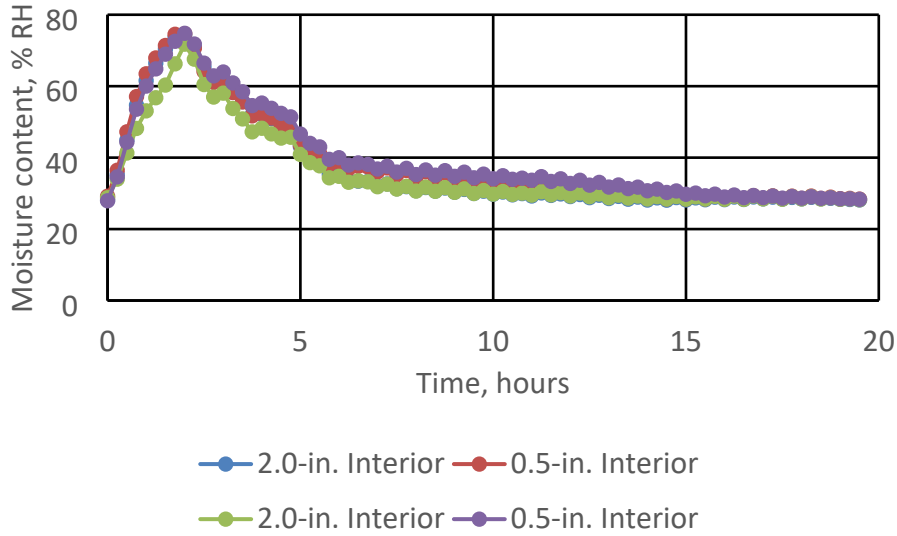
Figure 12: Moisture content measurements from capacitance sensors located near overdriven fasteners.

Figure 12 summarizes the test data from the four capacitance sensors located near overdriven fasteners. The data suggests that the location of the sensor with respect to its distance from the penetration and the surface on which it was mounted do not appreciably affect the measured moisture content.

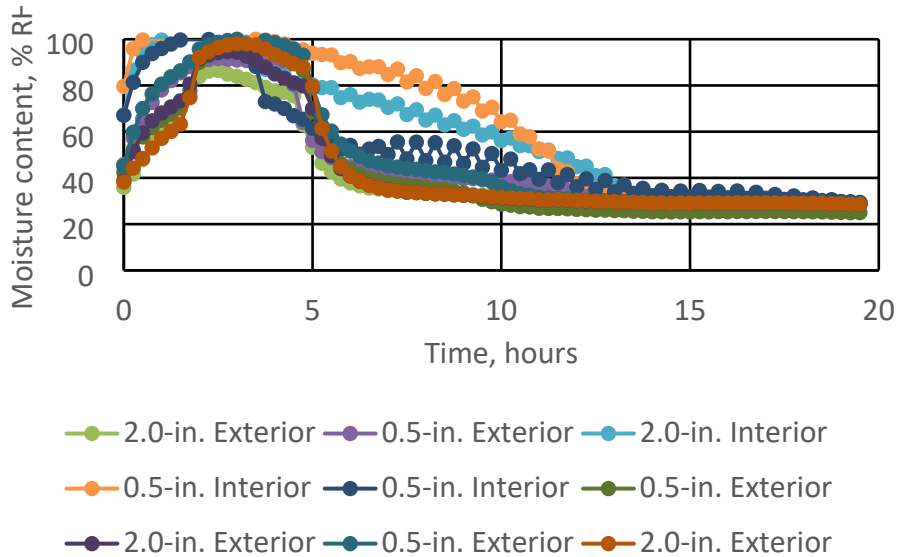
Figure 13: Moisture content measurements from capacitance sensors located near holes.

Figure 13 summarizes the test data from the nine capacitance sensors located near holes. Seven of the sensors reached near saturation (>95 percent moisture contents). After approximately 15 hours, all of the sensors were recording moisture contents near their original “dry” levels.

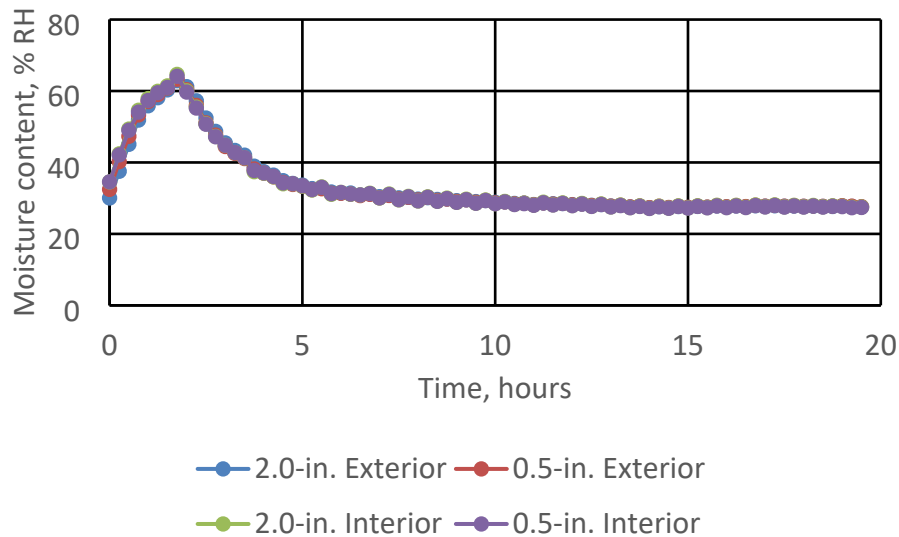
Figure 15: Moisture content measurements from capacitance sensors located away from any penetrations (no holes) in Panel E with no spray exposure.

Figure 15 shows the outputs of the capacitance sensors installed on Control Wall E that was not exposed to any spraying. This data shows that the relative humidity within the laboratory space increases during the testing process and that some of the increase in relative humidity is due to this change in laboratory conditions.

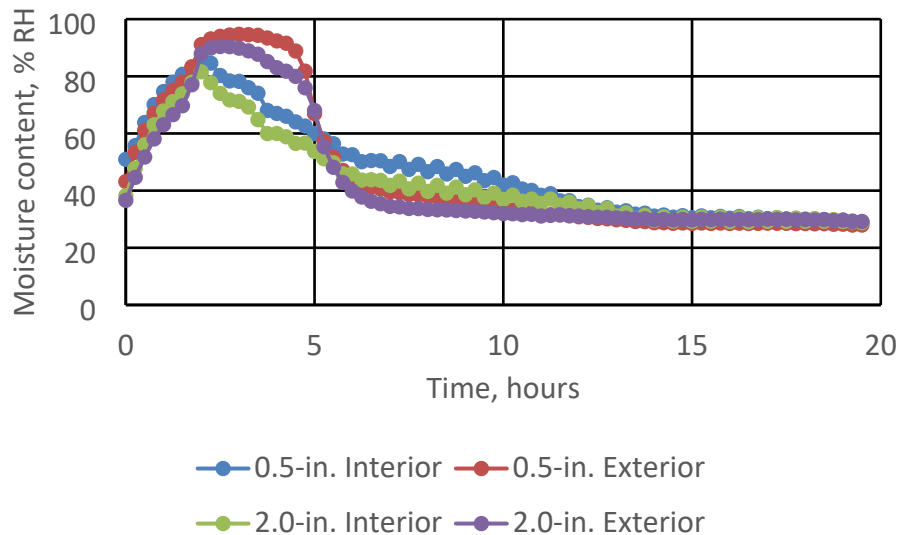
Figure 17: The average moisture content from capacitance sensors as a function of their distance from the water resistive barrier penetration and their installed surface.

Figure 17 depicts the average moisture content of all the capacitance sensors as a function of the sensor location (distance from the water resistive barrier penetration and the wall assembly surface that the sensor was attached) for all penetrations. Again, the exterior locations appear to sense slightly higher levels of moisture whereas the distance from the penetration appears to have little impact.

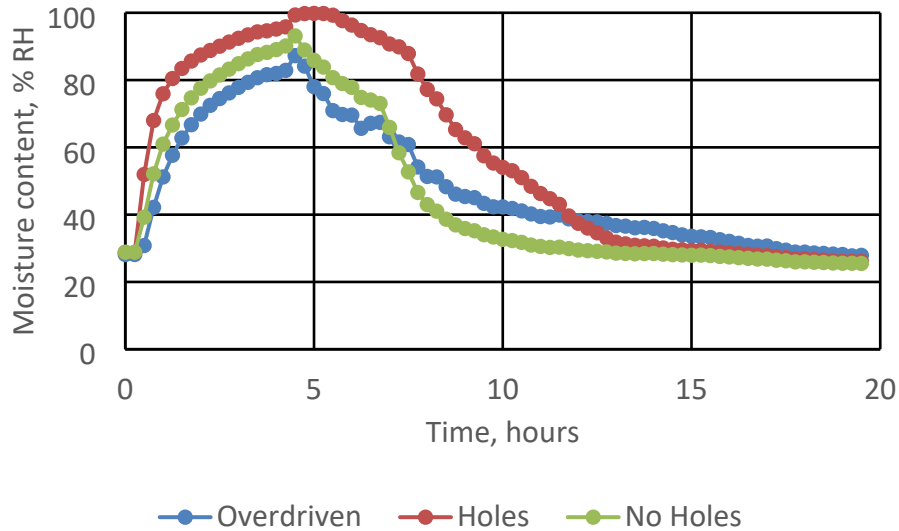
Figure 18: The average moisture content from capacitance sensors located near all penetration types during 4-hour exposure test.

Figures 18 and 19 summarize the average moisture contents measured by the capacitance sensors as a function of the penetration type and sensor location (distance from the water resistive barrier penetration and the wall assembly surface that the sensor was attached) for all penetrations for the 4-hour exposures, respectively. Similar to the 2-hour exposures, the sensors located near holes measure higher levels of moisture and the exterior locations appear to sense slightly higher levels of moisture whereas the distance from the penetration appears to have little impact.

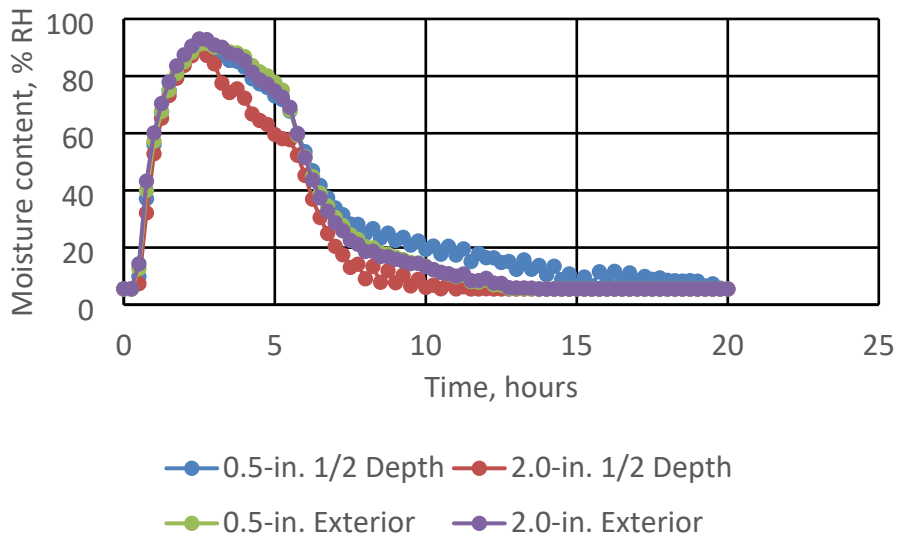
Figure 22: Moisture content measurements from moisture pin sensors located away from any penetrations (no holes).

Figure 22 depicts the average moisture content of the moisture pin sensors as a function of the sensor location (distance from the water resistive barrier penetration and the wall assembly surface that the sensor was attached) where there were no holes or penetrations in the water resistive barrier. The locations and the distance from the penetrations appear to have little impact.

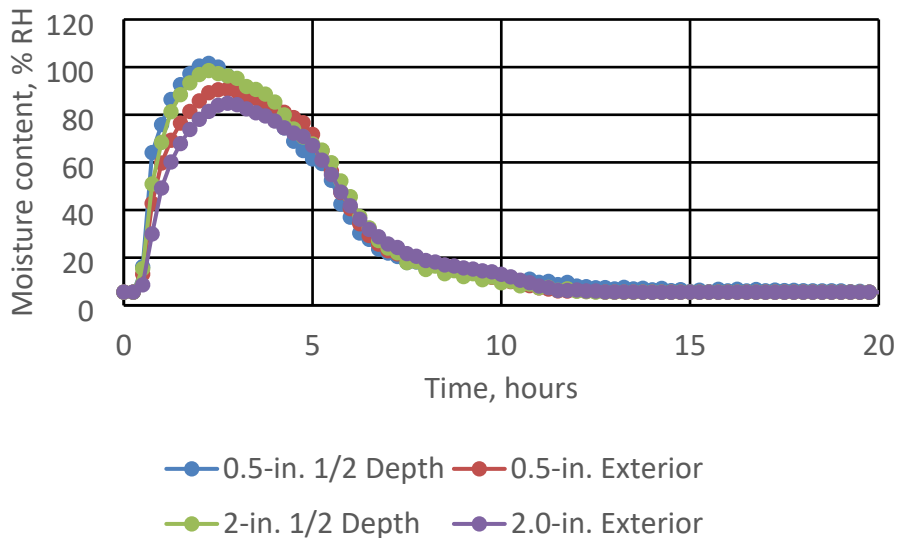
Figure 25: The average moisture content from moisture pin sensors as a function of their distance from the water resistive barrier penetration and their installed surface.

Figure 25 depicts the average moisture content of all the moisture pin sensors as a function of the sensor location (distance from the water resistive barrier penetration and the wall assembly surface that the sensor was attached) for all penetrations. In this instance, the moisture pins

located at mid-depth measure a slightly higher moisture content than the exterior locations whereas the distance from the penetration appears to have little impact.

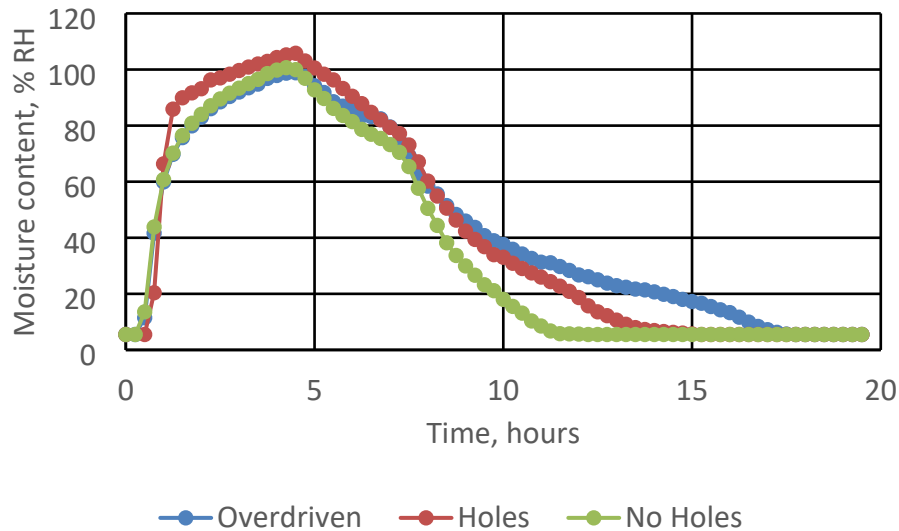
Figure 26: The average moisture content from moisture pin sensors located near all penetration types during 4-hour exposure test.

Figures 26 and 27 summarize the average moisture contents measured by the moisture pin sensors as a function of the penetration type and sensor location (distance from the water resistive barrier penetration and the wall assembly surface that the sensor was attached) for all penetrations for the 4-hour exposures, respectively. Similar to the 2-hour exposures, the sensors located near holes measure slightly higher levels of moisture, the ½ depth sensor locations sense slightly higher levels of moisture, whereas the distance from the penetration appears to have little impact.

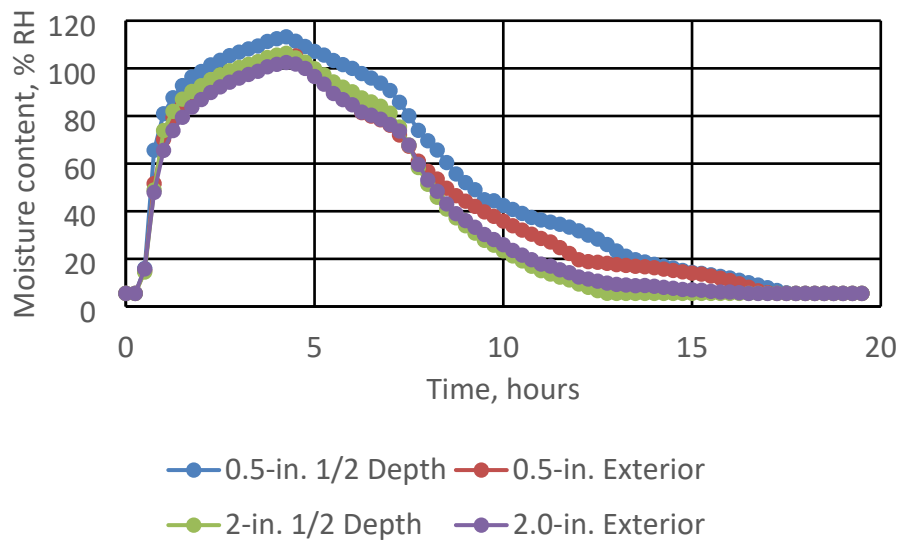
Figure 27: The average moisture content from moisture pin sensors as a function of their distance from the water resistive barrier penetration and their installed surface during 4-hour exposure test.
