AIR LEAKAGE PATHS IN A TYPICAL WOOD FRAMED WALL ASSEMBLY

by Mr. Laverne Dalgleish, Executive Directors of the Air Barrier Association of America

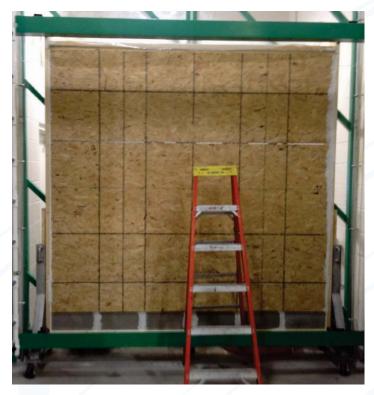
Figure 3: Test Wall Ready for Material Application

Details on the construction of this wall specimen was documented so that the base specimen could be replicated for additional testing with various types of air barrier materials being installed. To identify how much air would leak through a specific air leakage path, it was decided on to test the complete wall specimen to start with and then to seal one crack, gap or hole at a time and test after each air leakage path was sealed. The baseline wall was inserted into the test apparatus and the wall proved to be so leaky,
