## CONTRACTOR TIP

BY MR. COREY ZUSSMAN OF PEPPER CONSTRUCTION

**STUD TO STUD  
REPLACEMENT**

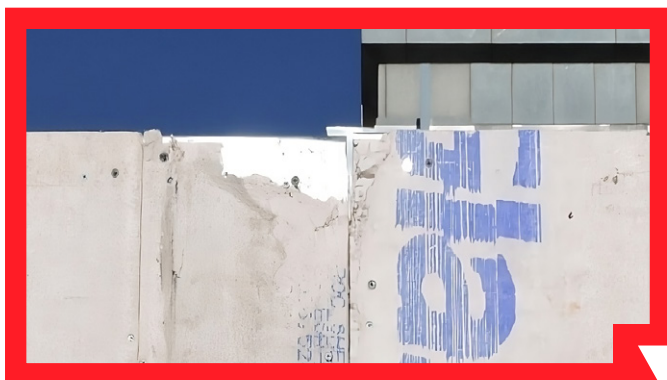
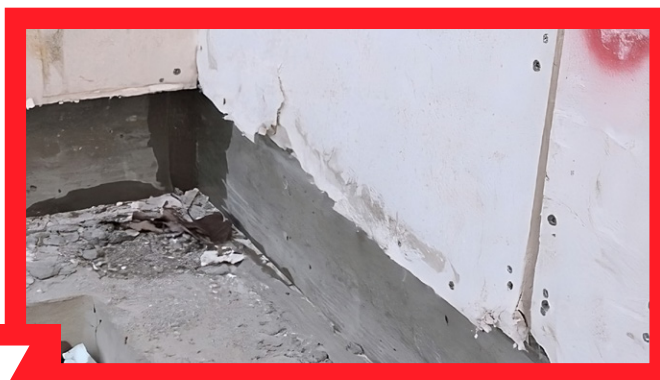
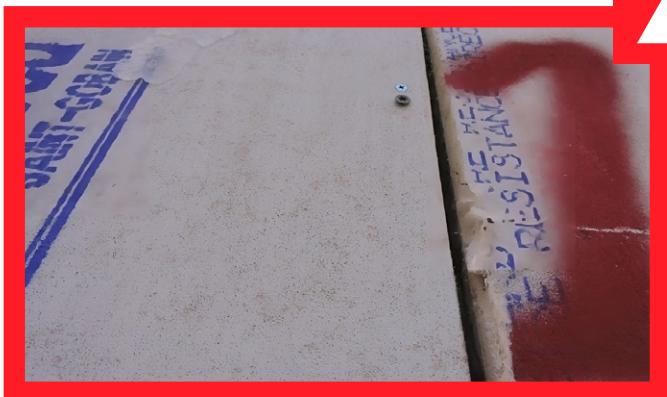
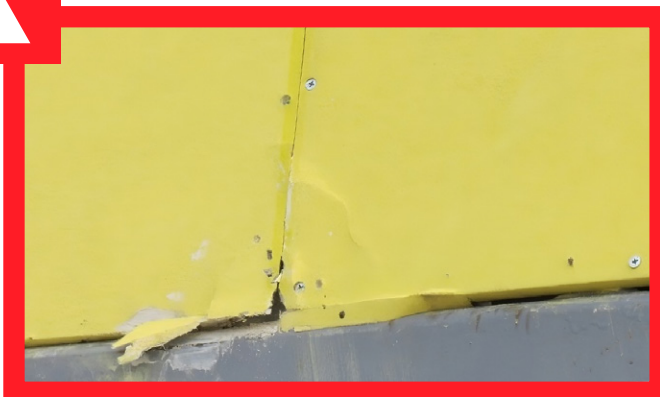
### **GYPSUM BOARD SHEATHING DAMAGE MUST BE REPAIRED (REPLACED) STUD TO STUD PRIOR TO ANY AIR/VAPOR BARRIER BEING INSTALLED**

When the paper face is torn off, the air/vapor barrier will get sucked into the gypsum and not properly adhere.

The air/vapor barrier needs to be fully supported.

Damaged sheathing or sheathing that the face material has been torn off or peeled off is not proper support for the air/vapor barrier – this will cause failure.

Always review your sheathing prior to the installation of the air/vapor barrier & have the sheathing contractor repair stud to stud.
