CONTRACTOR TIP

GYPHUM BOARD SHEATHING DAMAGE MUST BE REPAIRED (REPLACED) STUD TO STUD PRIOR TO ANY AIR/VAPOR BARRIER BEING INSTALLED

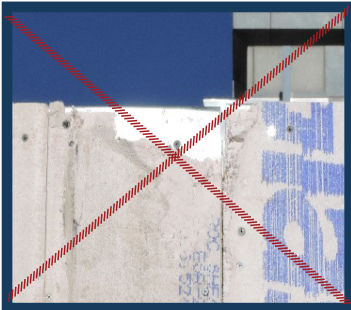
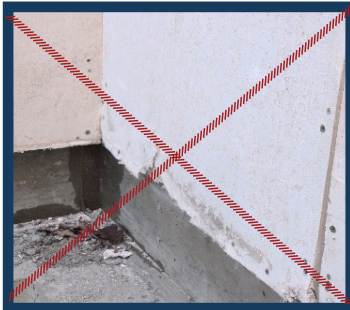
When the paper face is torn off, the air/vapor barrier will get sucked into the gypsum and not properly adhere.

The air/vapor barrier needs to be fully supported.

Damaged sheathing or sheathing that the face material has been torn off or peeled off is not proper support for the air/vapor barrier – this will cause failure.

Always review your sheathing prior to the installation of the air/vapor barrier & have the sheathing contractor repair stud to stud.
