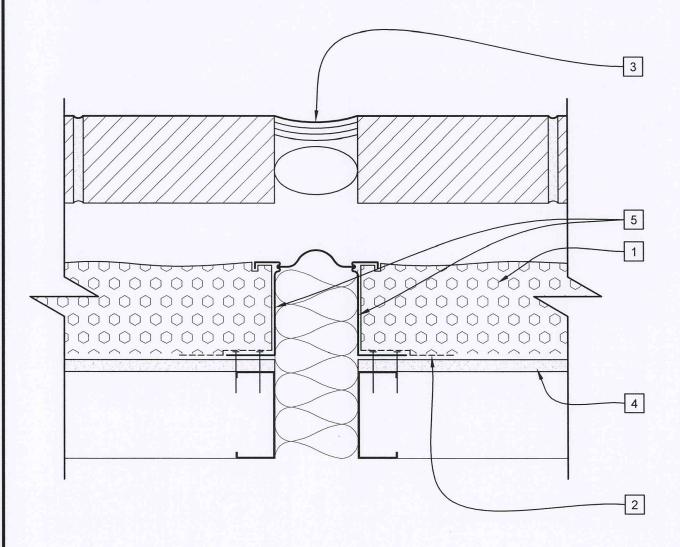
AB7

- 1 JM CORBOND III ™
- 2 TRANSITION MEMBRANE FULLY ADHERED TO WALL.
- 3 CAULK & BACKER ROD.
- 4 EXTERIOR GYPSUM SHEATHING.
- 5 PRIME METAL AS NEEDED.

EXPANSION JOINT

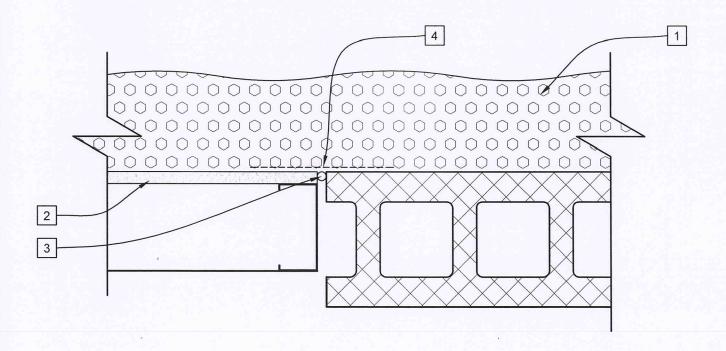
AB8

- 1 JM CORBOND III ™
- 2 EXTERIOR GYPSUM SHEATHING.
- 3 BACKER ROD AS NEEDED.
- 4 TRANSITION MEMBRANE FULLY ADHERED TO WALL.

CHANGE IN SUBSTRATE

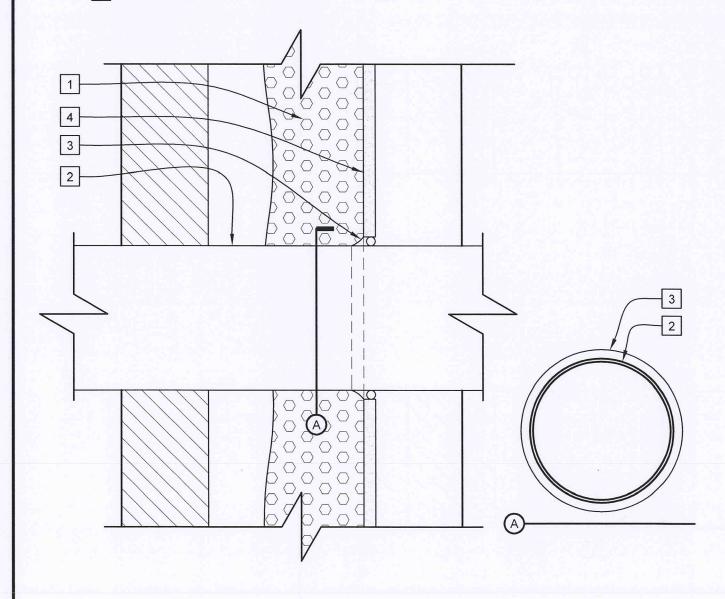
AB9

- 1 JM CORBOND III ™
- 2 PIPE.
- 3 URETHANE FLEXIBLE CAULK.
- 4 EXTERIOR GYPSUM SHEATHING.

PENETRATIONS - AMBIENT TEMPERATURE

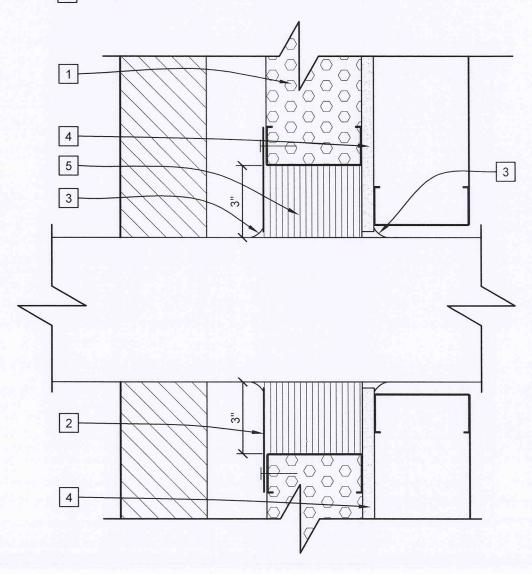
AB10

- 1 JM CORBOND III ™
- 2 METAL FLANGE
- 3 FIRE CAULK.
- 4 NON COMBUSTIBLE SHEATHING.
- 5 ROCKWOOL

HIGH TEMPERATURE PENETRATIONS

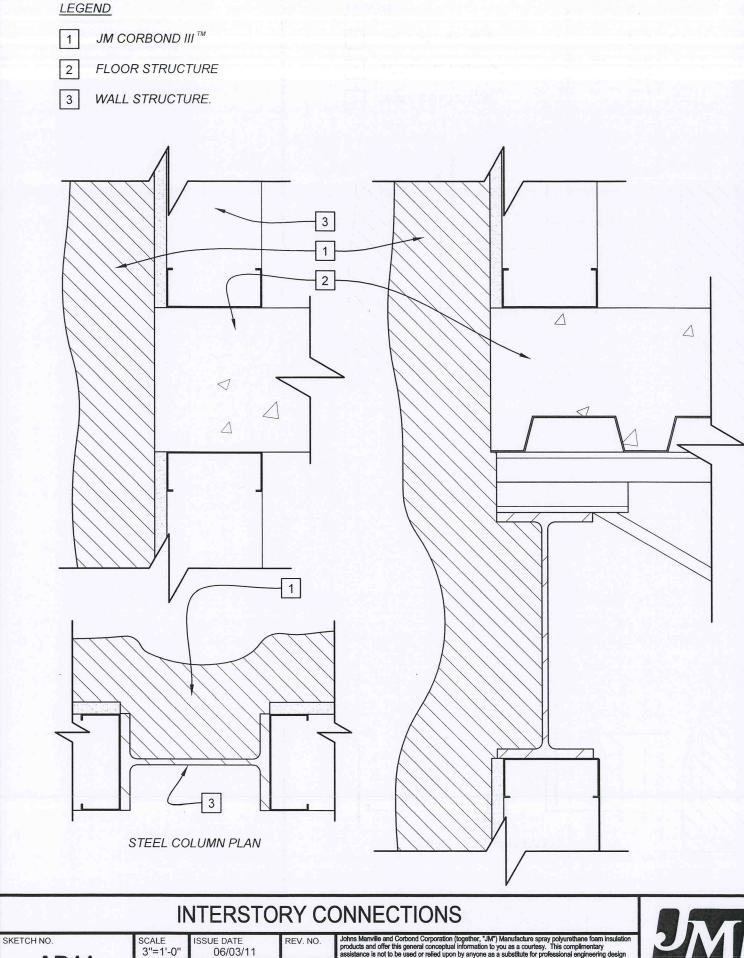
AB11

INTERSTORY CONNECTIONS.dwg

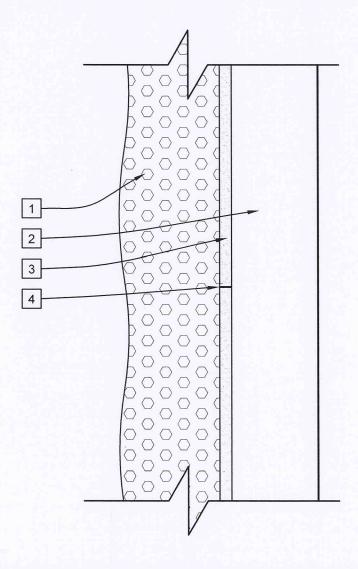
AB12

- 1 JM CORBOND III ™
- 2 WALL STRUCTURE.
- 3 EXTERIOR GYPSUM SHEATHING.
- 4 JOINT IN EXTERIOR GYPSUM.

SUBSTRATE JOINTS & DEFECTS
